Toronto Case Studies

Case Study #3

Client: 21&23 Carlton St.

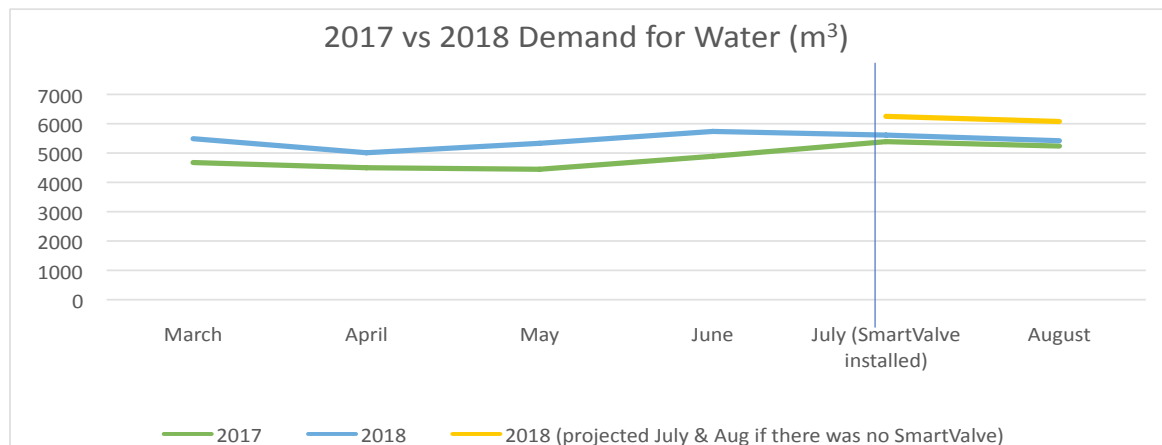
Month	2017	2018	Percent Difference
March	4,676m ³	5,489m ³	+17%
April	4,499m ³	5,010m ³	+11%
May	4,447m ³	5,332m ³	+20%
June	4,889m ³	5,737m ³	+17%
SmartValve™ was installed in end of June 2018			
July	5,389m ³	5,612m ³	+4%
August	5,238m ³	5,420m ³	+3%

It is important to compare the savings of the SmartValve™ by referencing changes in water demand that occurred *prior* to the installation of the SmartValve™, *if there was a major change in yearly consumption*. In this way can we add necessary context to calculations. We can clearly see that the SmartValve™ moderates the increased demand for water, bringing consumption close to 2017 levels.

BMI has done an extensive study of water demand at 21 & 23 Carlton St for the months leading up to the installation of the SmartValve™. Up to 4 months before the installation, the demand for water increased by an average of 16.25% as compared to the same months in 2017.

The SmartValve™ was installed in the end of June, and we immediately see a significant decrease in the difference between consumption in July 2017 and in July 2018, and the same for August 2017 and August 2018. **The SmartValve™ is saving close to 15% in water consumption.**
